Retaining value

How a staged approach to investigations and targeted strengthening helped a client realise its ambition for reuse and extension

Mary Ward Centre, London: Risk management of a heavy retrofit and vertical extension of a 1970s concrete-framed building

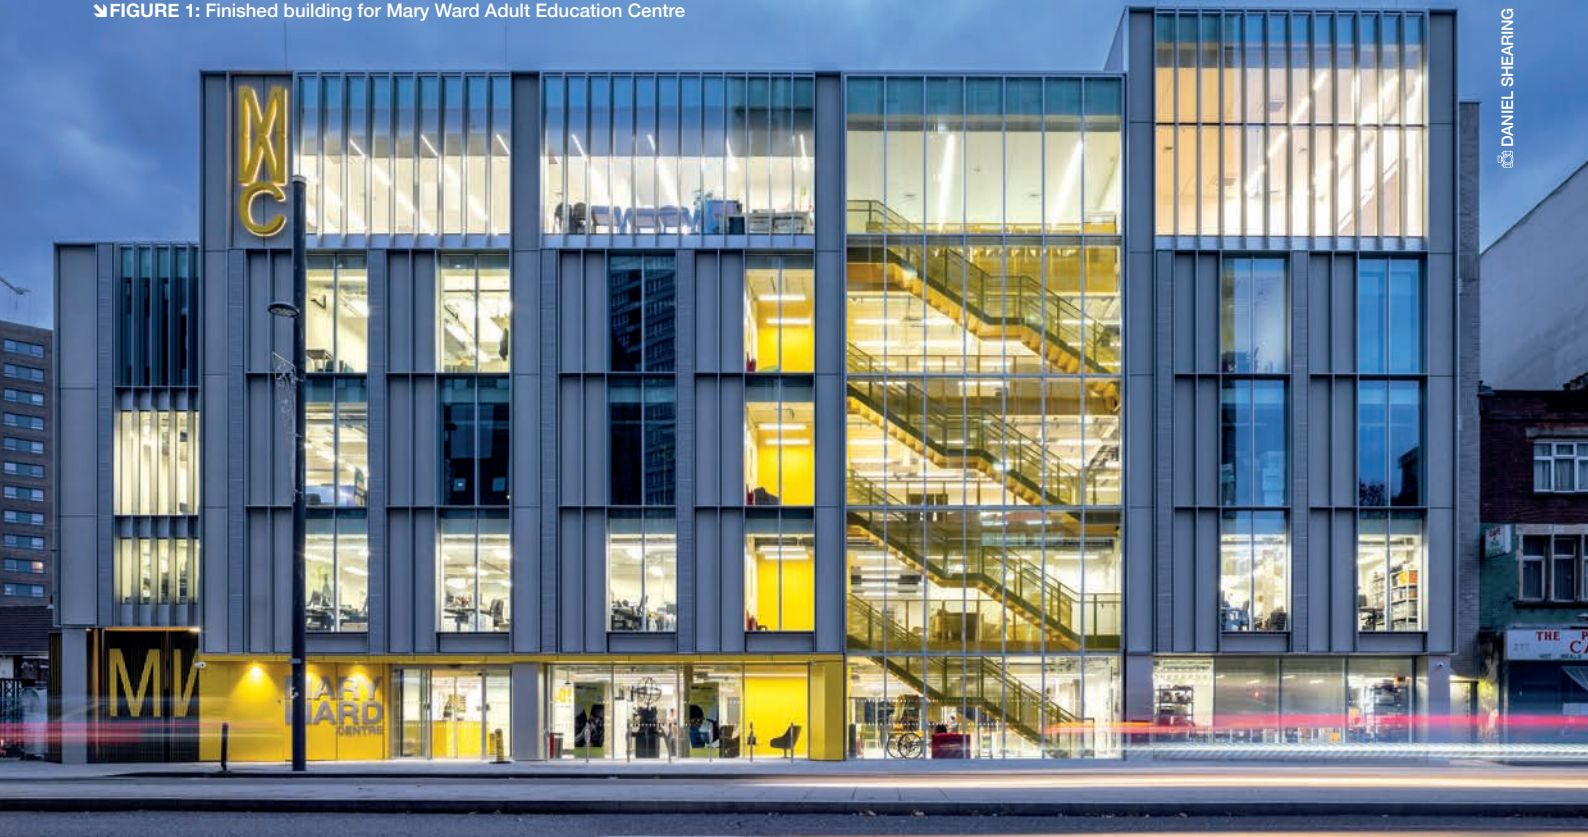
FIGURE 1: Finished building for Mary Ward Adult Education Centre

The building was subsequently extended by two storeys on top and 1.5m to the front to occupy a portion of the wide pavement space which the client owned (**Figure 1**).

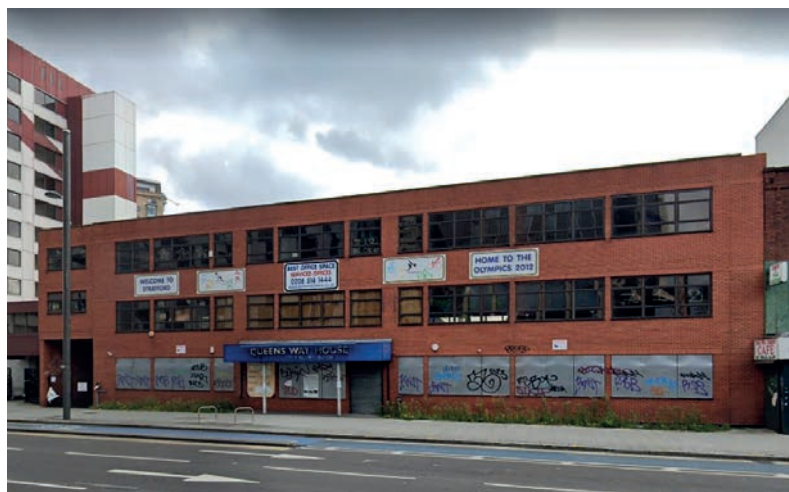
FIGURE 2: Queensway House (front elevation), pre-intervention

The building, designed for office use, occupied a split-level site, with the front portion three storeys and the rear four storeys (Figure 2). It had been

The structure, which is a typical 1970s reinforced concrete (RC) frame, has a 220–255mm deep beam-and-pot slab, cast into supporting perimeter and internal beams. Mass concrete pads support the columns, with ground-bearing slabs at ground and lower ground-floor levels, and a retaining wall along the centre of the building, forming the steps in level to the rear. The building had a blockwork central lift and stair core which had been retrofitted during

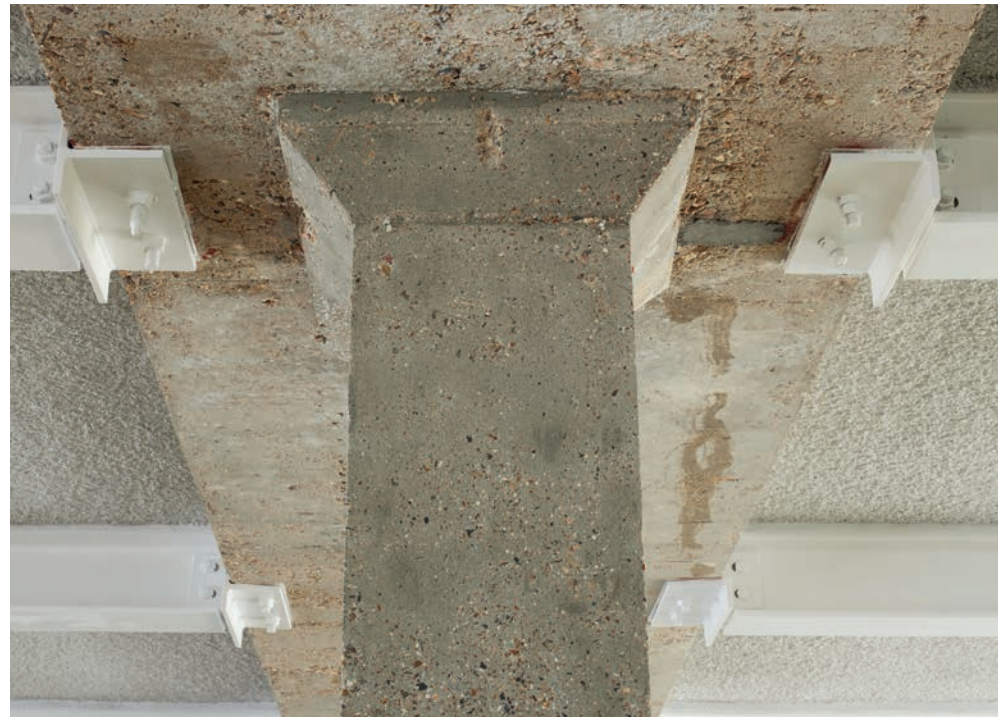
FIGURE 3: Concrete repairs and new steelwork to support additional upper storeys

Based on the findings of the intrusive investigations, the existing roof RC ribbed slab was found to be insufficient in bending to support the proposed floor build-ups and imposed load. It therefore required strengthening (**Figure 3**).

Rather than demolish the existing 'weak' roof slab, we proposed to introduce a steel grillage below the slab. This grillage split the existing slab span, allowing the slab to support the increased floor loadings. The grillage also acts as a transfer structure to support the new columns above. Retaining the slab reduced the need for temporary works and for a new floor to be installed.

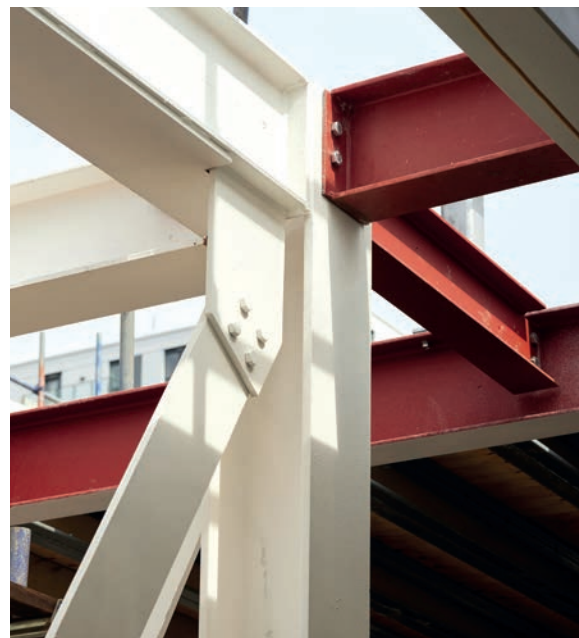
FIGURE 4: New steel framing at roof level

The additional storeys were designed to be constructed using steelwork and a metal deck slab (**Figures 4 and 5**), with an exposed structural aesthetic to clearly showcase the interface between the new and existing sections and the structural modifications. This exposed structure suited the budget of the client and the ambition to achieve a low-carbon design. Alternative options reviewed for the additional storeys included precast concrete planks and a mass-timber frame. The mass-timber solution was found to be the lowest carbon but was cost-prohibitive for the client.

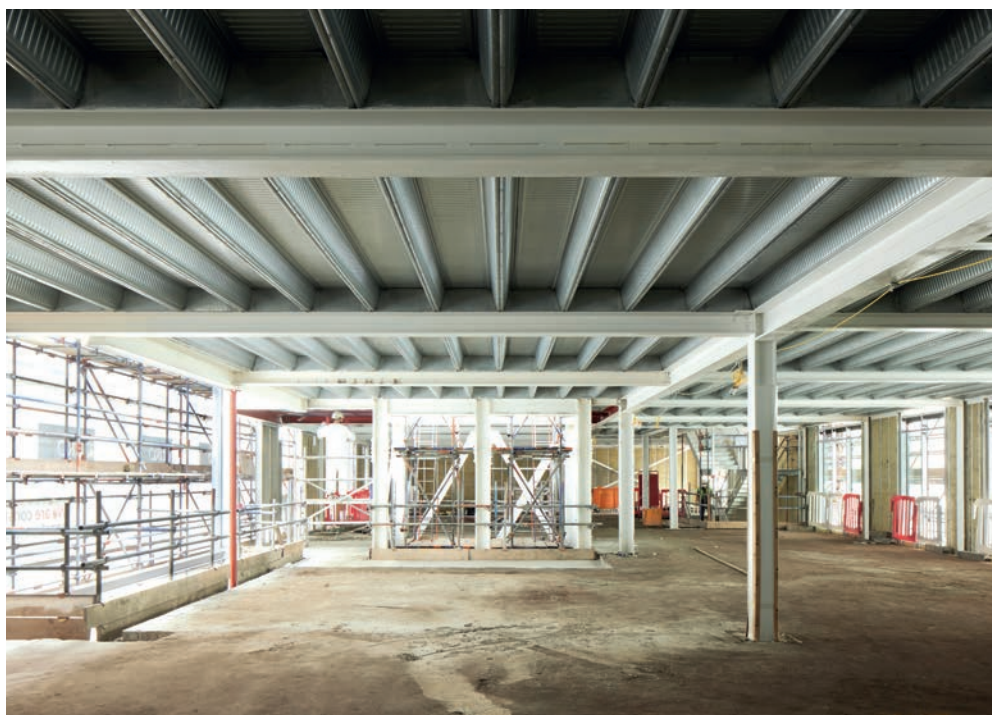
FIGURE 5: New composite floor for one of additional storeys, and view of central lift core

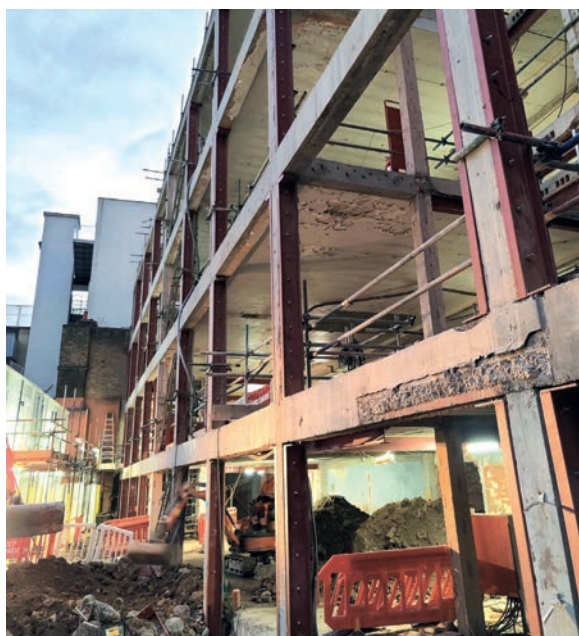
FIGURE 6: Existing concrete frame with steel strengthening

Existing columns were strengthened with parallel-flange channel sections bolted either side and packed tight to the floor and soffit to take the additional loading (**Figure 6**).

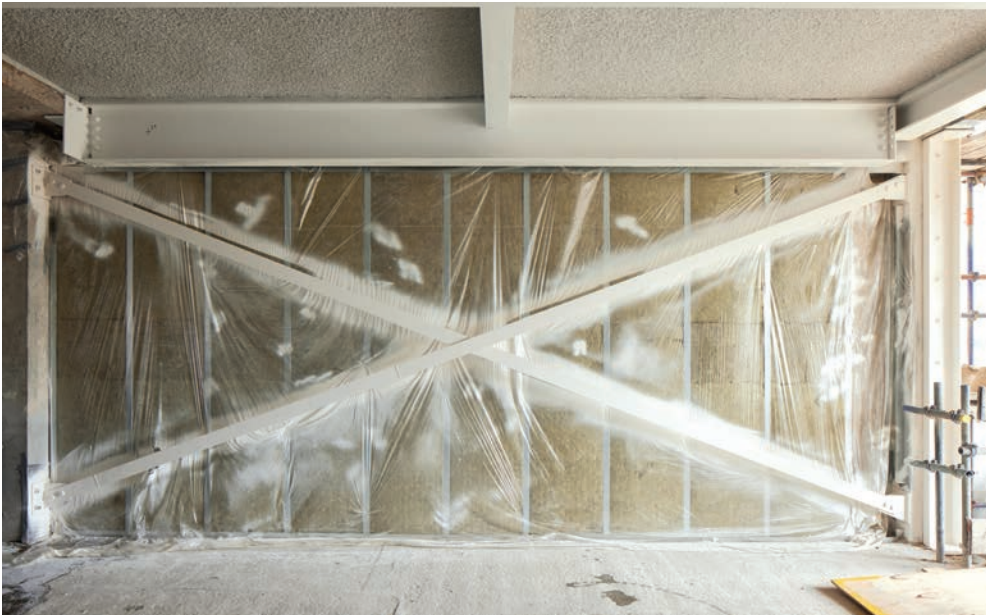
FIGURE 7: New steel cross-bracing installed at either end of building to provide additional stability

A new braced lift core and steel cross-bracing at either end of the building enhanced the stability to account for the increased wind load from the taller structure with the addition of two storeys. The end-bay cross-bracing was a hybrid of new steelwork and existing concrete columns and beams (**Figure 7**). Investigative works confirmed the existing elements, including rebar in the columns through to the foundation, had capacity for the additional shear and axial loads and could withstand the design forces without further strengthening being required.

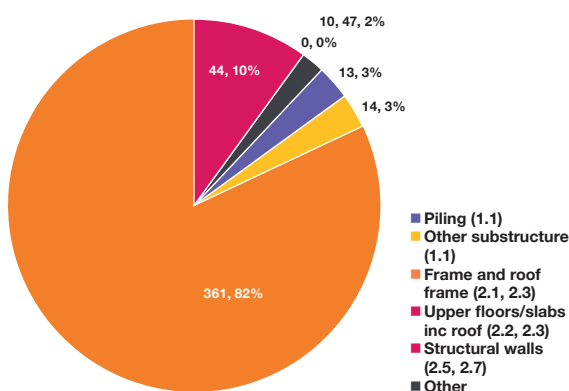
Scheme performance against targets:

SCORS: 137 kgCO₂e/m²

RIBA: 156 kgCO₂e/m²

LETI: 228 kgCO₂e/m²

FIGURE 9: Carbon emission breakdown by element, storey addition and strengthening design option (tCO₂e)

was a reduction of over 40% in embodied carbon compared with the construction of a new building (not including the demolition of the existing frame), with the scheme meeting RIBA and LETI targets (**Figures 9 and 10**).

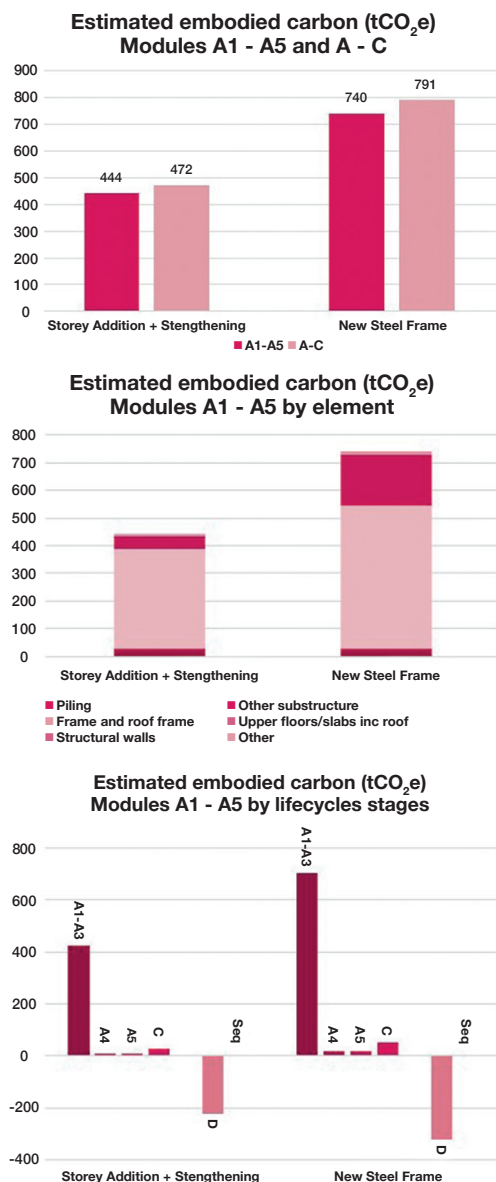
FIGURE 10: Carbon emission comparison – refurbishment and steel-frame extension vs new-build steel frame

The carbon assessment for the structural refurbishment calculated there
